June 28, 2019
File No. 262018.063

Subject: Department of Natural Resources Washington Geological Survey,
School Seismic Safety Assessment Project, Contract No. AE 410 -
Seismic Evaluation for **Shaw Island School District**

School Buildings Evaluated in the Shaw Island School District

Shaw Island, Shaw Island School, Admin/RR Building

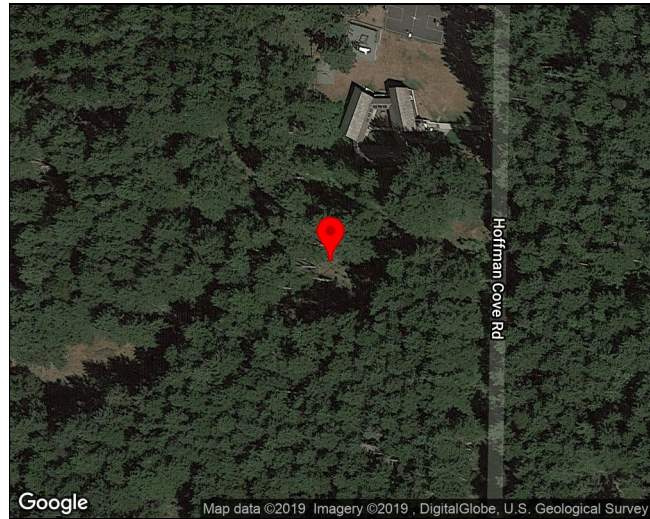
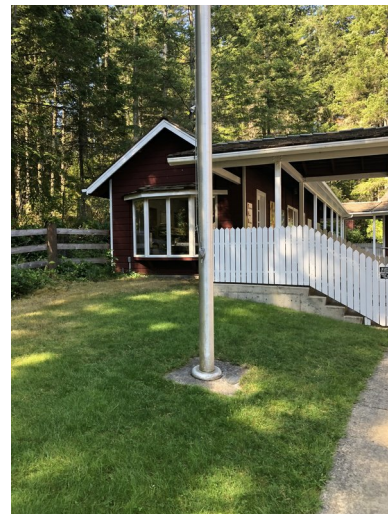
The Administration Building at the Shaw Island is a one-story 1096 square foot building built in 1952. The building is of wood frame construction with wood interior and exterior walls and a wood framed roof. The building is founded on conventional spread footings. The building has a cedar shake roof that is supported by 1X framing members that are gapped and span to the wood roof framing, this limits that ability of the roof structure to function as a roof diaphragms.

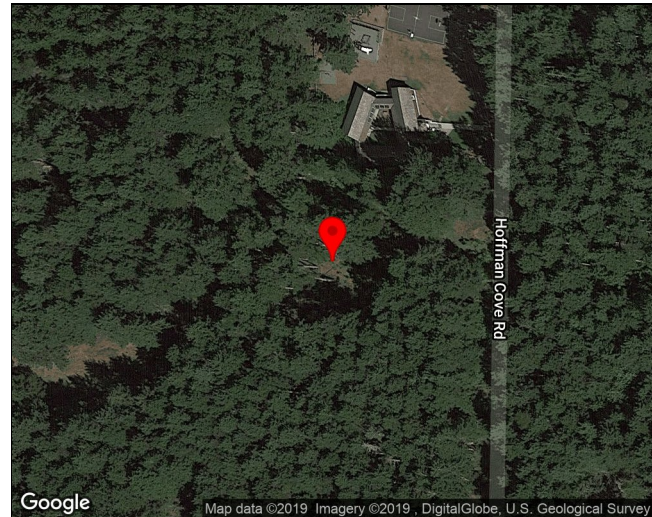
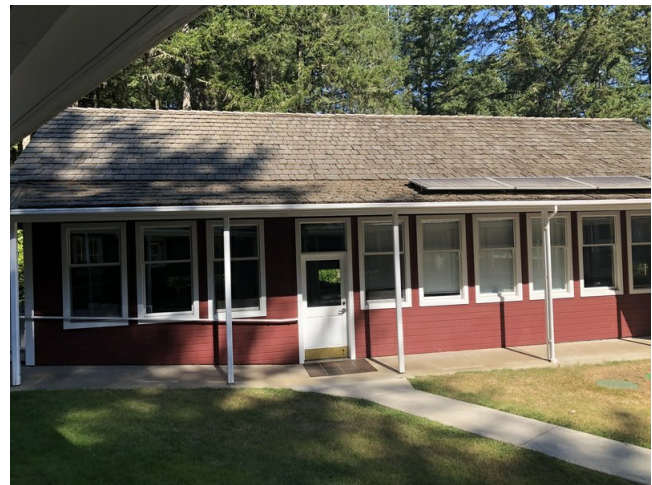
The Intermediate Building at the Shaw Island is a one-story 1,009 square foot building built in 1992. The building is of wood frame construction with wood interior and exterior walls and a wood framed roof. The building is founded on conventional spread footings. The building has a cedar shake roof that is supported by 1x framing members that are gapped and span to the wood trusses, this limits that ability of the roof structure to function as a roof diaphragm.

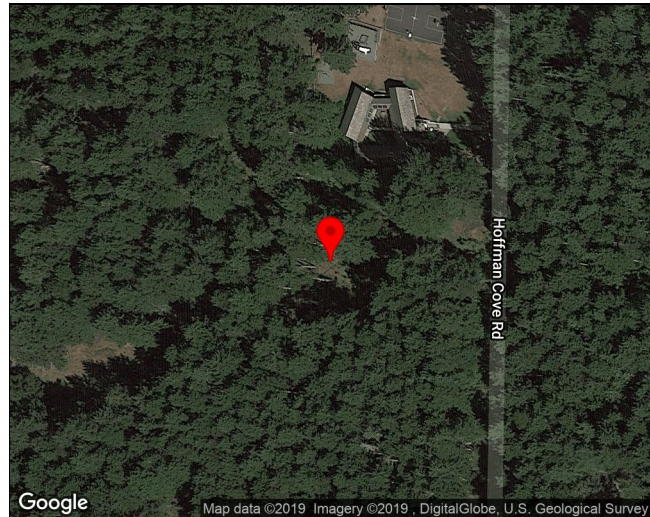
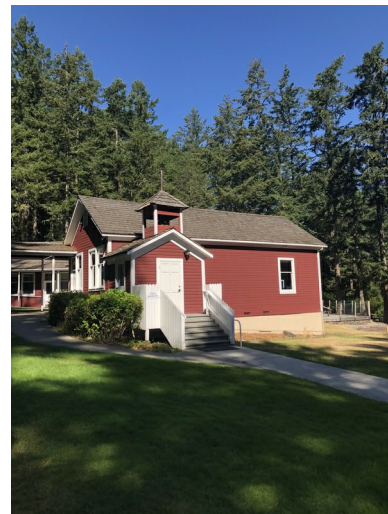
The Primary Building at the Shaw Island is a one-story 892 square foot building built in 1902. The building is of wood frame construction with wood interior and exterior walls and a wood framed roof. The building is founded on conventional spread footings. The building has a cedar shake roof that is supported by 1x framing members that are gapped and span to the wood roof framing, this limits that ability of the roof structure to function as a roof diaphragms.
